Evaluation of In-Pavement, Flashing Warning Lights on Pedestrian Crosswalk Safety

John F. Van Derlofske
Lighting Research Center, Rensselaer Polytechnic Institute
21 Union Street
Troy, N.Y. 12180
Telephone: (518) 687-7100
Fax: (518) 687-7120
Email: vandej3@rpi.edu

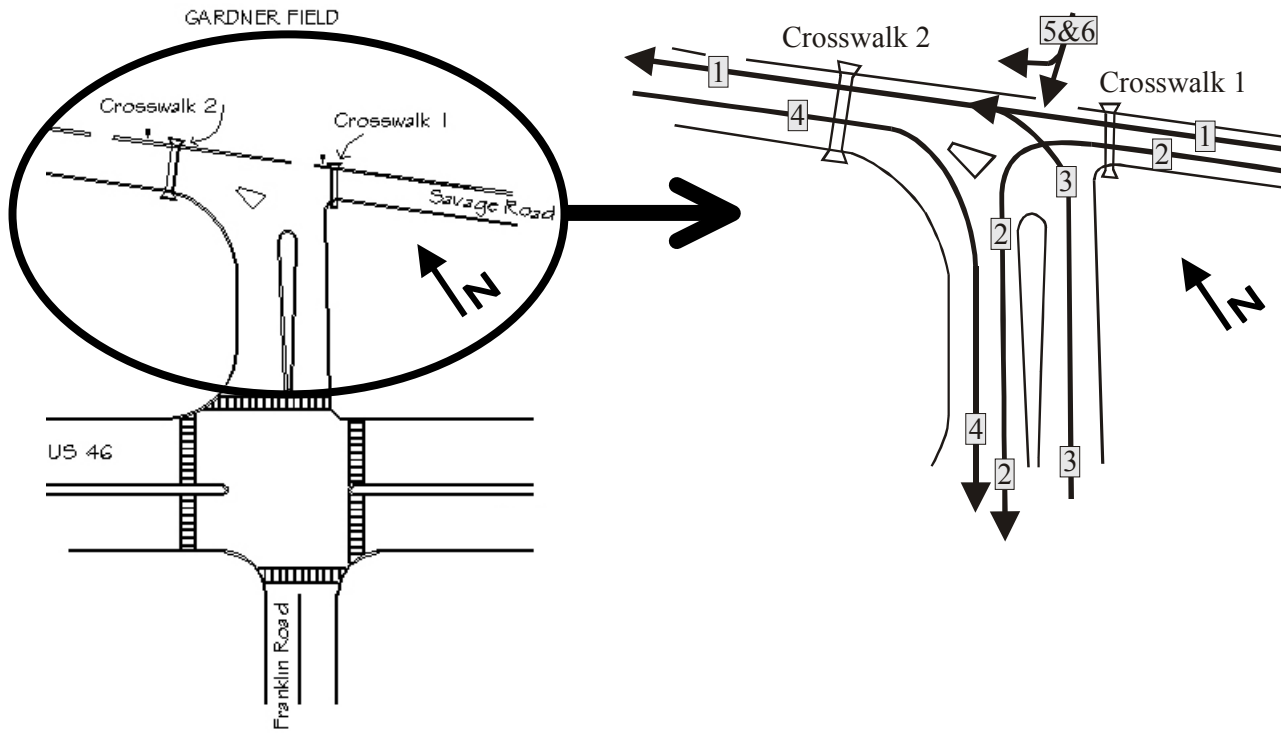
FIGURE 1 A plan of the evaluation site with close up view showing the six directions evaluated.

The Department of Transportation of the State of New Jersey identified a site for the evaluation in Denville, New Jersey. FIGURE 1 shows a plan of the site. Although no pedestrian collisions have been reported at this location it was felt that this complicated intersection is dangerous for pedestrians. The site is adjacent to a major traffic-signal-controlled intersection between US Route 46, a four-lane, divided highway, and Franklin Road, a two-lane road. To the North of Savage Road is Gardner Field, an extensive recreational area. The width of Savage Road is 24 ft at crosswalk 1 and 32 ft at crosswalk 2. The speed limit on Savage Road is 30 mph. The east leg of Savage Road (at Franklin Road) is one-way westbound. Access to the parking lot of Gardner Field is off Savage Road, just to the west of crosswalk 2. Egress from the parking lot is actually into the junction adjacent to crosswalk 1. This complicated pattern of lanes means there are six possible routes for drivers to pass through the junction between Franklin Road and Savage Road. The six directions include:

- Direction 1 – West on Savage Road, straight through the intersection
- Direction 2 – West on Savage Road, south onto Franklin Road
- Direction 3 – North on Franklin Road, west onto Savage Road
- Direction 4 – East on Savage Road, south onto Franklin Road
- Direction 5 – South on Franklin Road, from Gardner Field
- Direction 6 – West on Savage Road, from Gardner Field

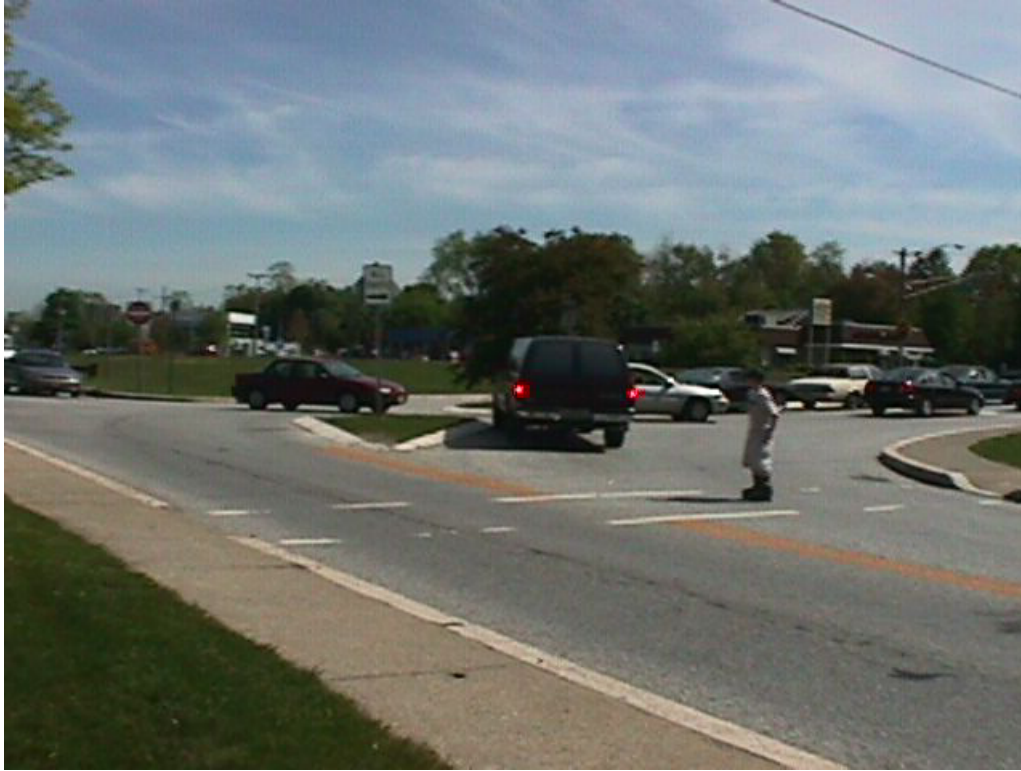
FIGURE 2 Crosswalk 2 at the time of the first evaluation.

The first evaluation was made on Saturday, 12th June 1999. At this time, there was only one marked crosswalk at the site, that being crosswalk 2. This crosswalk was linked to a sidewalk on the northwest side of Franklin Road. There was no sidewalk on the southeast side of Franklin Road so there was no marked crosswalk 1 at this point. FIGURE 2 shows the marking of crosswalk 2 from the sidewalk on Savage Road on the day of the evaluation. It is clear that the original marking of crosswalk 2 consisted of two parallel lines across the road, although by the time of the evaluation, the lines had been badly eroded by traffic.

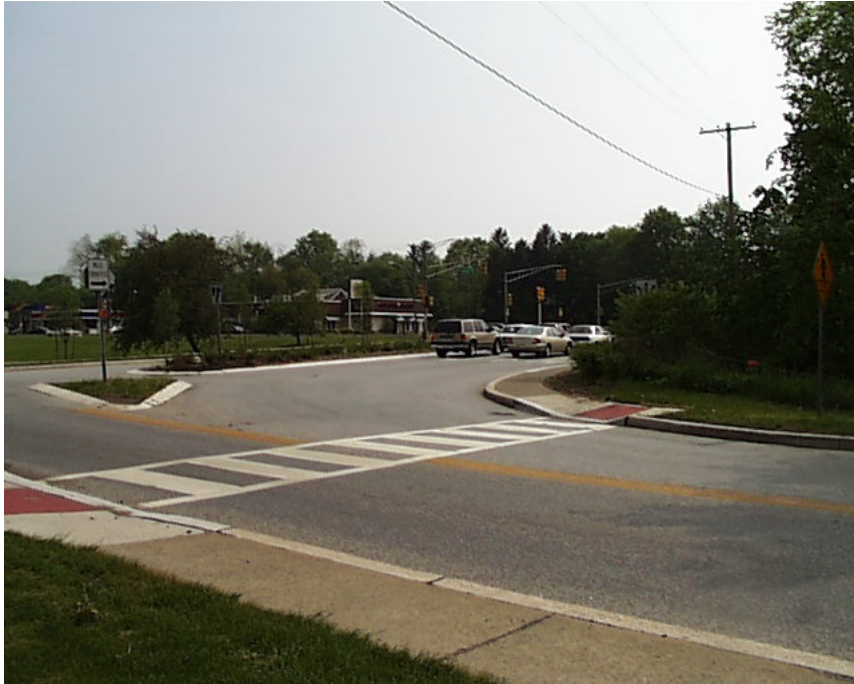
FIGURE 3 Crosswalk 2 at the time of the second evaluation.

The second evaluation took place on Saturday, 13th May 2000. By this time, a sidewalk had been constructed on the southeastern side of Franklin Road and a new crosswalk across Savage Road (crosswalk 1), complete with ADA ramps, had been finished. Both crosswalks had been newly striped and advanced warning signs were added. Specifically, the striping consisted of alternate 2-ft-wide bars of white paint and 2-ft-wide pieces of asphalt, arranged to form a grating pattern, the upper and lower boundaries of the grating being closed by a continuous white paint line of 9" thickness. This is commonly called a high visibility crosswalk. The overall width of both crosswalks was 7 ft. FIGURE 3 shows a view of crosswalk 2 at this stage.

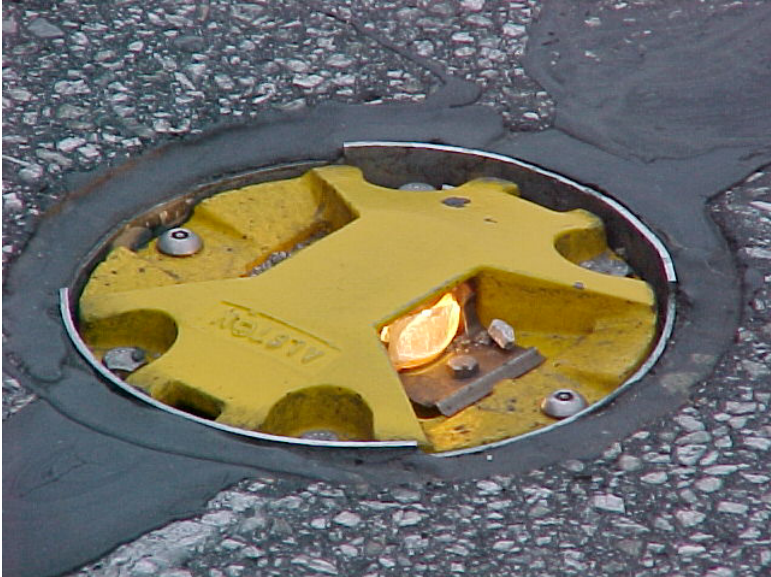
FIGURE 4 Installed in-pavement flashing warning light.

The third evaluation took place on Saturday, September 23rd, 2000, one week after the completion of the installation of the in-pavement flashing warning lights. The in-pavement flashing warning lights (Model ZA230) were purchased from Traffic Safety Corporation of Sacramento, California and installed by the New Jersey Department of Transportation. FIGURE 4 shows a close-up of one of the in-pavement flashing warning light units as installed.

The unit was originally designed for use on airport runways. It is of rugged construction and designed to be set low in the pavement as not to be damaged by snowplows. The light source used in the unit is a 45 W tungsten halogen lamp. The light output of the unit is predominantly in two directions, through apertures set at 180° to each other. The unit is installed so that these directions are along the main axis of the road. In Denville, only the direction towards approaching traffic emits light (the other direction is sealed). The clear lens in the aperture of the unit directs a high luminous intensity beam along the road in the direction of approaching drivers. The color of the flashing warning lights was white. Four ZA 230 units were installed on crosswalk 1 and six units on crosswalk 2. FIGURE 5 shows the installation at crosswalk 1.

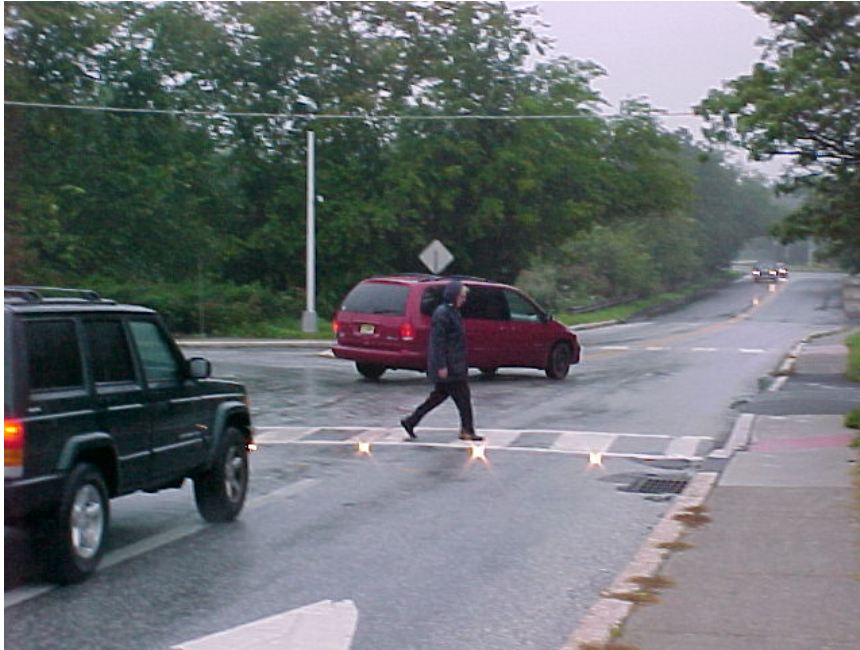
FIGURE 5 Crosswalk 1 with the in-pavement flashing warning lights installed and operating.
